IDR Sheet	1	of	1	Sheets	Final Record Book	Page
Contract			Day		Date	
C-7852			Tuesday		August 10, 2010

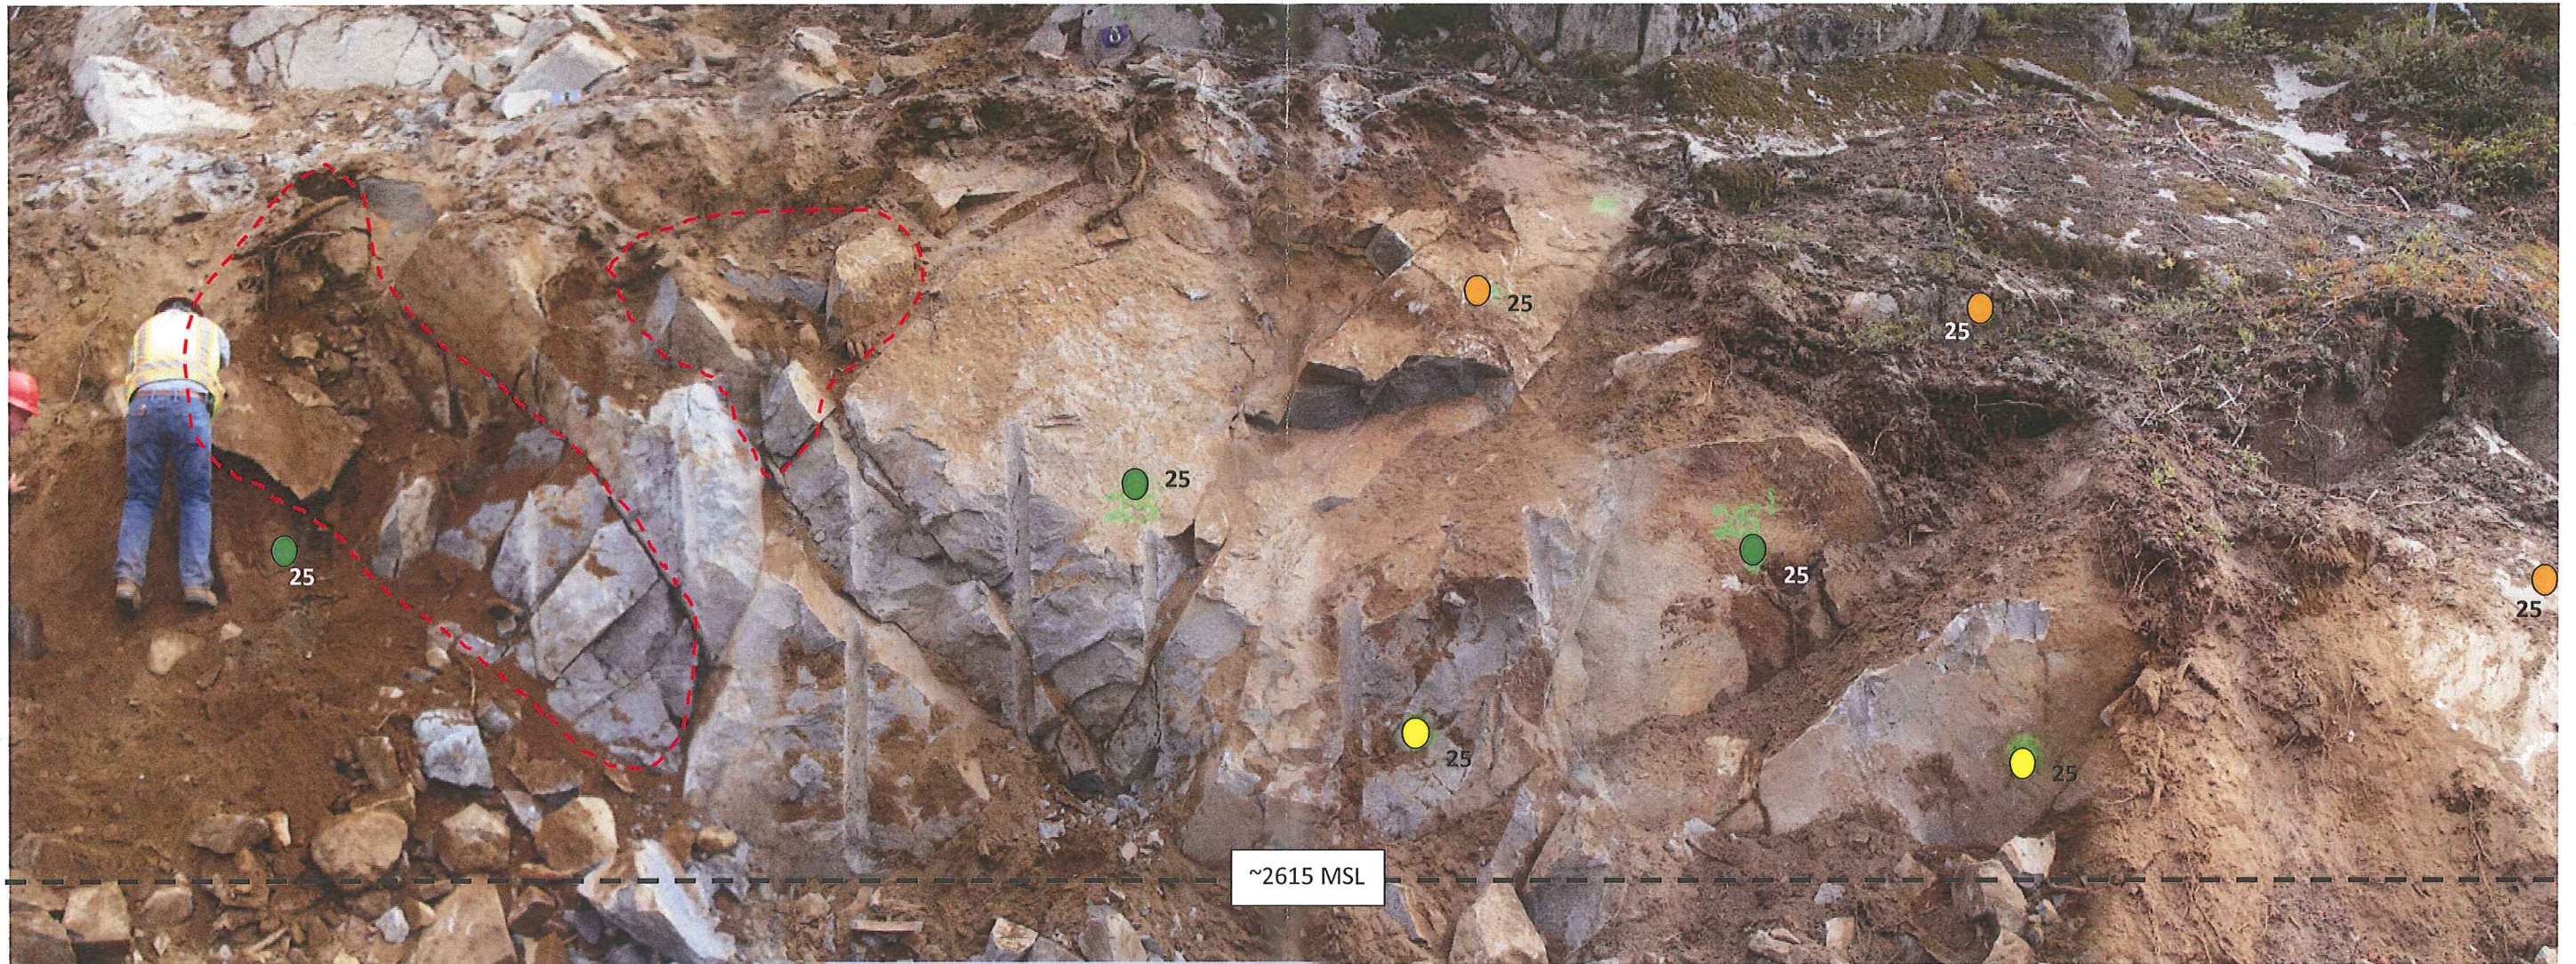
Brad and I walked upslope to approximate station LW 1333+50 to 1334+00 (8/9/2010 blast) and located three 25 foot long Type L pattern dowels located approximately 12 feet below the crest of the cut (as per plan), two 25 foot long Type L spot dowels and three 25 foot long pre-excavation dowels to approximate elevation 2615 MSL (Figure 1). The blasters requested to conduct a small pioneer shot around approximate station LW 1334+00 to 1334+25 to clean up the slope for the next bench. I discussed this request with Steve Lowell and he indicated that this was acceptable as long as all the dowels were installed.

Figure 1. A photograph showing Lift 1 inspection from approximate station LW 1333+50 to 1334+00 to approximate elevation 2615 MSL.

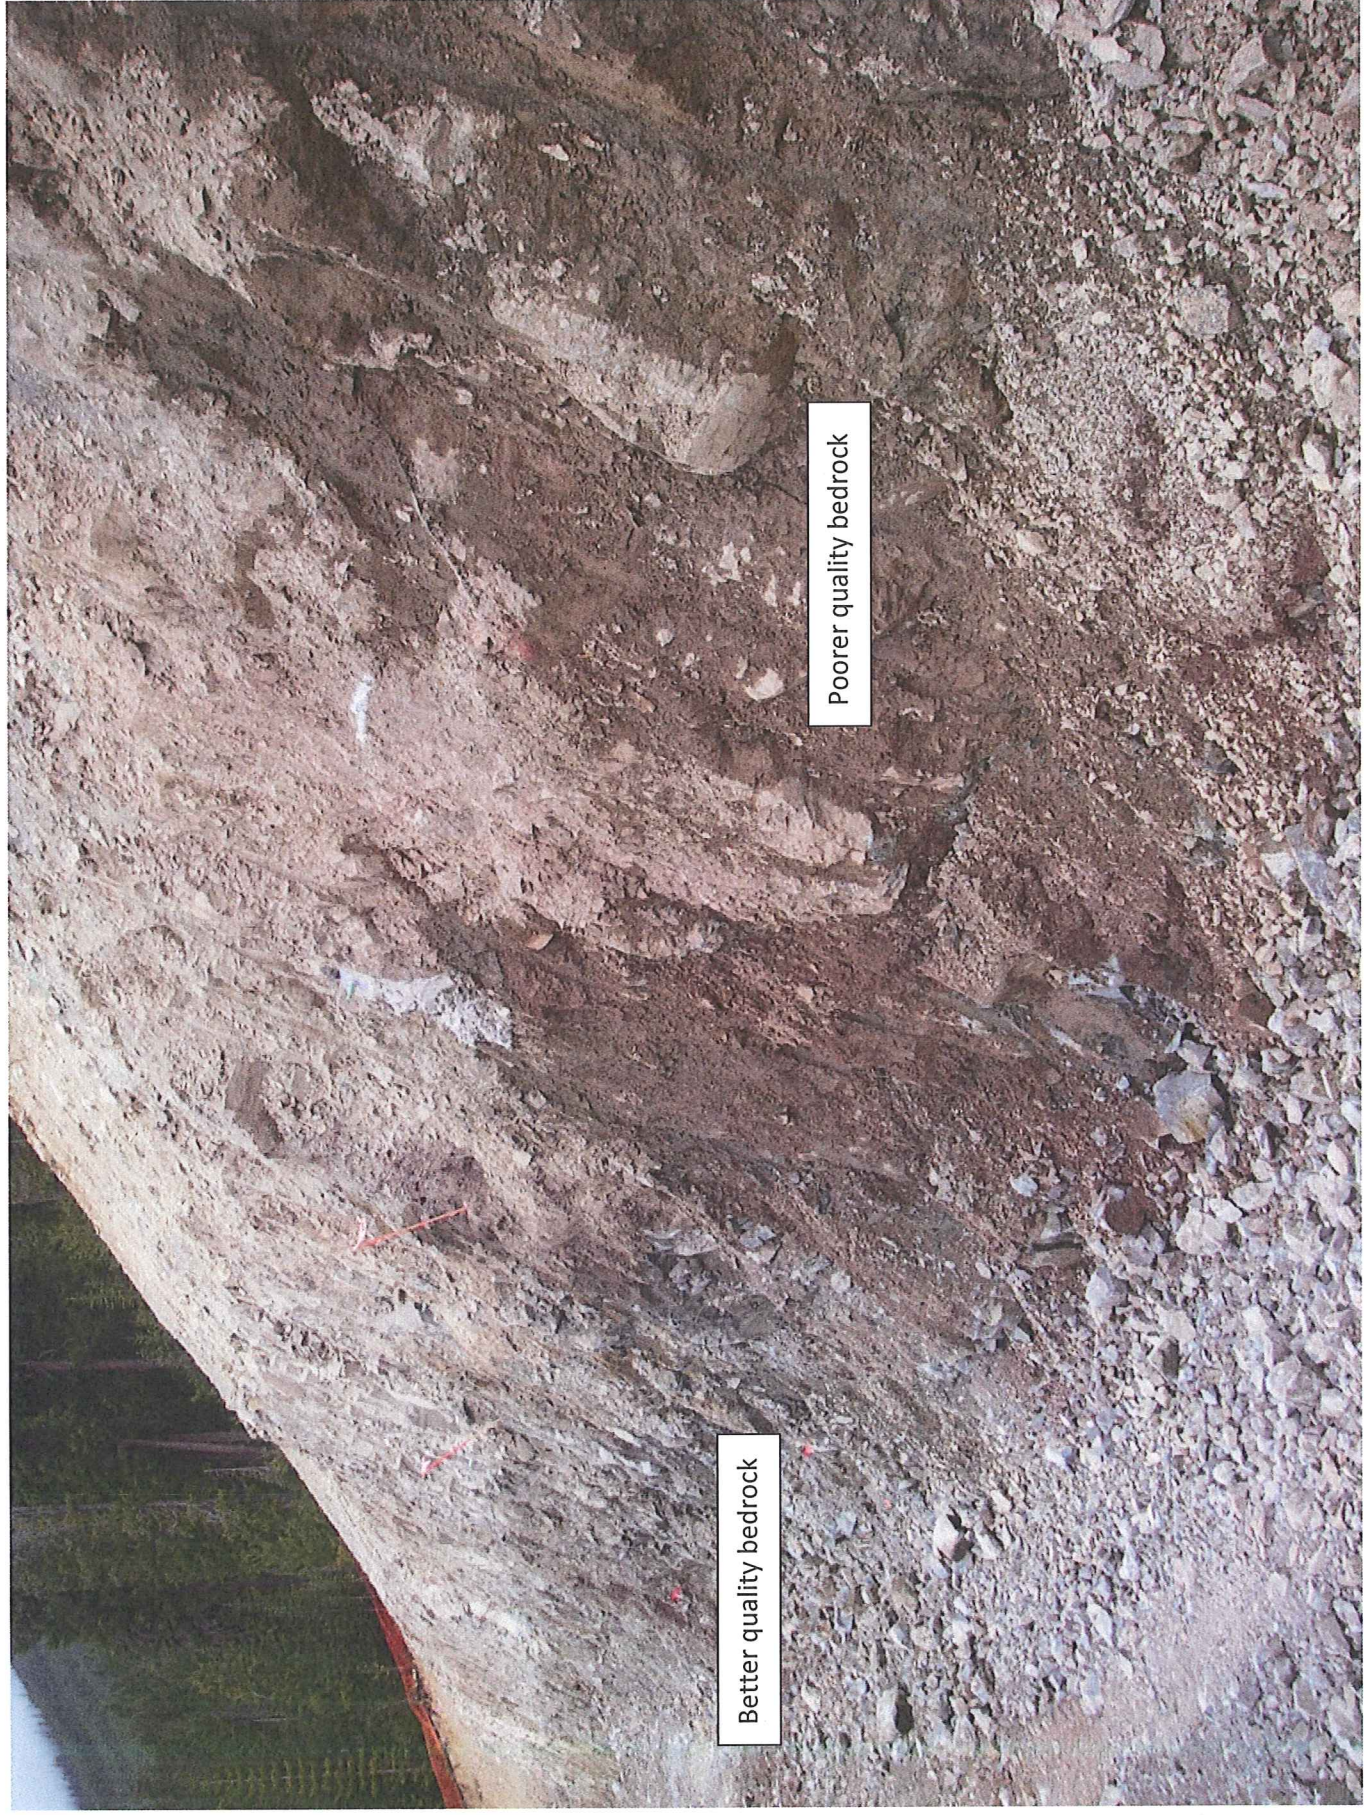
Brad and I reviewed the slope around station LW 1316+25 to 1317+50 to approximate elevation 2555 MSL. The rock appeared to be better quality than Lift 1; however, there are still localized zones of very weak, friable basalt bedrock with wet zones (Figure 2). I discussed the inspection with Steve Lowell and he indicated that he and Norm Norrish discussed the west side of the project and they decided they wanted the poorer quality bedrock exposed to grade and we would reassess the slope once the entire length is open. Following this assessment, we would determine what needs to be done at this location. I told Brad that we can continue to blast and muck this section as long as the prism and strain gauge systems were working within the contract specifications.

Figure 2. A photograph of the exposed slope at approximate station LW 1317+00. Note the localized zones of poorer quality, weak, friable basalt bedrock.
